# COOPER LAKE DAM AND WEST DIKE

## PHASE I INSPECTION REPORT NATIONAL DAM SAFETY PROGRAM

Name of Dam: Cooper Lake Dam and West Dike  
County and State: Ulster County, New York  
Inventory Number: NY 00081

Name of Dam: Cooper Lake Dam and West Dike  
State Located: New York  
County Located: Ulster County  
Stream: Tributary to the Saw Kill  
Date Of Inspection: June 27, 1978

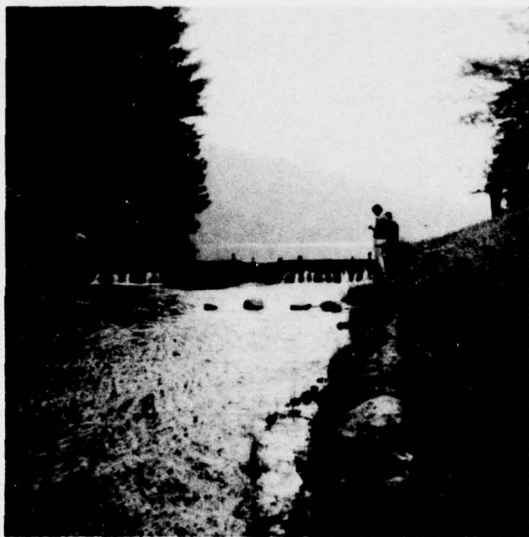
e. Downstream Channel - The downstream channel is adjacent to the toe of the main dam. Debris is present in the form of tree trunks and fallen trees. A small foot bridge is also present allowing access to fields downstream of the dam. The debris is sufficiently concentrated to cause considerable obstruction to flow in the event of high discharges.

CHANNEL DOWNSTREAM OF SPILLWAY

3) All debris should be removed from the downstream channel, especially near the toe of the dam where fallen trees and tree trunks could cause considerable obstruction to flow.

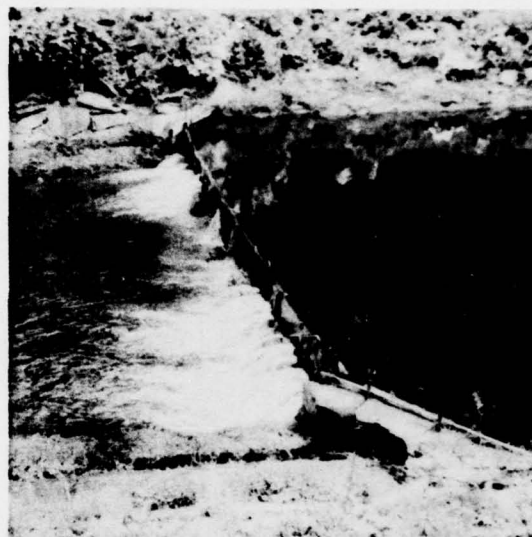
The timber stoplog installed above the crest of the concrete spillway is deteriorating and considerable seepage is evident between the concrete and the timber. The concrete lined spillway approach channel and downstream channel are in good condition with only minor concrete cracking.

SPILLWAY

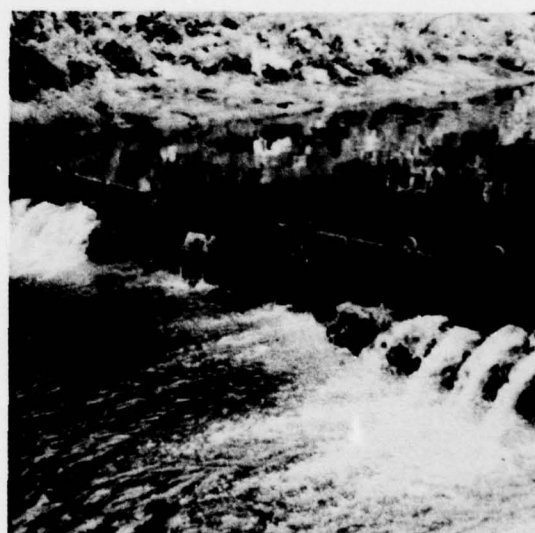
CLOSE-UP VIEW OF SPILLWAY

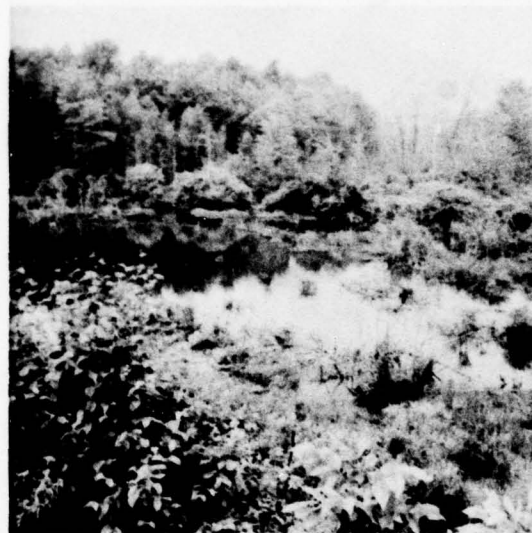
The downstream face of most of the dike is covered with trees, heavy brush and ferns or aquatic plants. Standing water is present at the downstream toe along most of the length of the dike and some of this water is discolored. Beaver dams exist downstream of the dike.

POND IMMEDIATELY DOWNSTREAM  
OF WEST DIKE

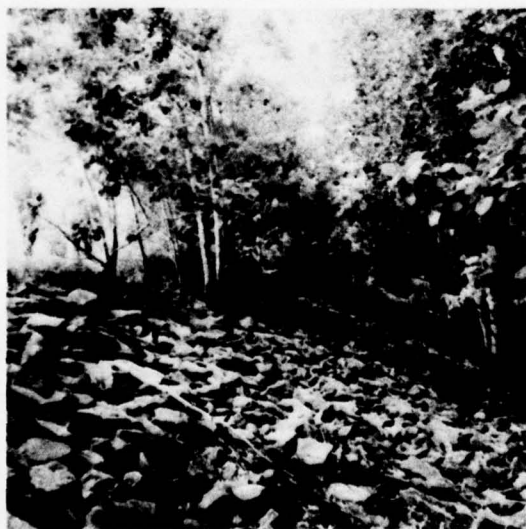
2) The West Dike - Most of the downstream face of the embankment is wooded indicating extensive root systems. In addition, standing water is present along most of the length of the West Dike at its toe. As discussed in Section 2 above, Beaver Dams may have caused this condition. Although the elevation of the roadway is fairly uniform, numerous small depressions were noted. No abnormal depressions were noted on the upstream face.

DOWNSTREAM FACE OF WEST DIKE

3) The downstream face of the dike should be cleared of the heavy growth of trees and brush. The few trees on the upstream face should also be cut near the groundline.
